DEPARTMENT OF TRANSPORTATION

Contract #: 04-0120F4Cty: SF/ALA Rte: 80 PM: 13.2/13.9File #: 99.28**WELDING INSPECTION REPORT****Resident Engineer:**Siegenthaler, Peter**Address:** 333 Burma Road**City:** Oakland, CA 94607**Report No:** WIR-021081**Date Inspected:** 25-Feb-2011**Project Name:** SAS Superstructure**OSM Arrival Time:** 700**Prime Contractor:** American Bridge/Fluor Enterprises, a JV**OSM Departure Time:** 1900**Contractor:** Zhenhua Port Machinery Company, Ltd (ZPMC) Chanxing Island **Location:** Shanghai, China

Bridge No: 34-0006**Component:** OBG Segment**Summary of Items Observed:**

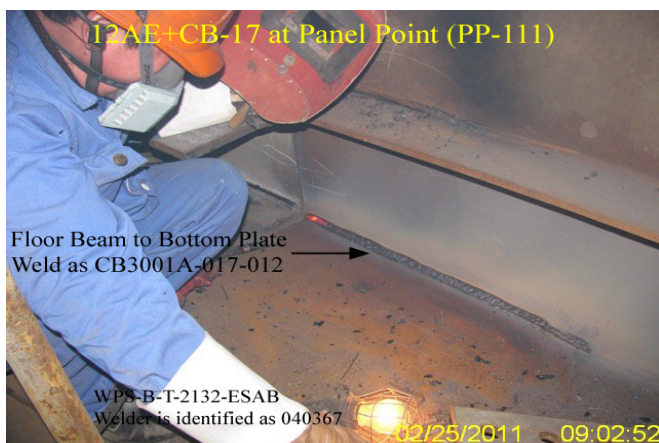
ZPMC welding personnel performing Flux Core Arc Welding of Fillet welds joining the floor beam to bottom plate weld joint located on 12AE+CB-17 at Panel Point (PP-111). The weld is designated as CB3001A-017-012. The welder is identified as 040367. ZPMC QC Mr. LI YANG was onsite monitoring the welding variables. The inprocess Flux Core Arc Welding appears to be progressing in compliance with WPS-B-T-2132-ESAB. Further weld detail mention in attached picture.
